DIVING SYSTEMS INTERNATIONAL, Inc. 425 Garden Street

CAUTION Bulletin No. 3 of '95 7 DECEMBER, 1995

Subject: Drawstring Neck Dam

Products Affected: Kirby Morgan SuperLite-17A/B & U.S. Navy MK-21

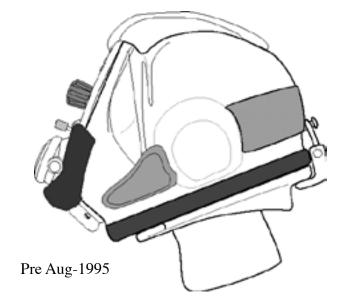
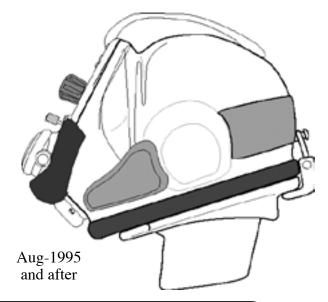
The neck chute of the dam is now angled, allowing the helmet to rest in a more comfortable position and lessening front end ride up. It also fits a wider variety of neck sizes.

THIS NECK DAM IS NOT A ONE SIZE FITS ALL TYPE. IT MUST BE TRIMMED TO FIT (SEE REVERSE)

If the Neck Dam is too tight on the neck or too hard to get over the head, the Neck Dam *MUST BE TRIMMED*.

Trim 1/4 inch at a time.

Try the Neck Dam Assembly on for comfort. The blue side must be against your neck. Slide the Yoke onto the neck from behind; spread the opening of the Neck Dam and pull it down over the head. The Neck Dam should be moderately easy to pull over the head and fit snug enough to prevent leaking, but not so tight that it limits or restricts circulation. If the Neck Dam is too tight on the neck or too hard to get over the head, the Neck Dam *MUST BE TRIMMED*. Trim 1/4 inch at a time, as shown, until the proper fit is attained. **Do not trim more than 1/4 inch at a time.** Do not use a loose fitting Neck Dam. It will allow leakage and possible flooding into the helmet.
