# Kirby Morgan Dive Systems, Inc.®

## Safety Bulletin #1 of 2008, June 2, 2008 Dry Suit Inflation Installation onto a Kirby Morgan Helmet 'B' Side Block, Part Numbers 505-024 & 505-025

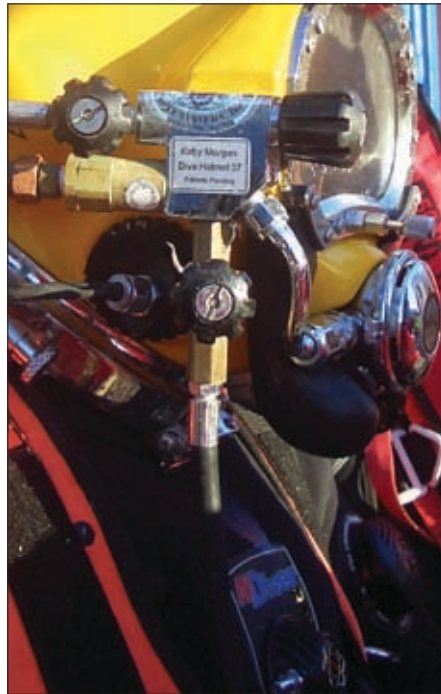
The practice of installing a dry suit inflation whip with modified fittings onto a KM 37 side block has been reported to IMCA.

- ◆ The modification to the side block assembly shown in the photograph above, **is not recommended**
- ◆ The leverage on the brass fitting is extremely high giving a high potential for breakage
- ◆ The fitting at the bottom of the side block is a  $\frac{3}{8}$ " straight thread fitting with an O-ring seal which is not designed to sustain this kind of leverage

An in-line valve is not deemed necessary, as long as a good quality and suitably approved inflator hose or the KMDSI restrictor adapter Part Number 555-210 is used.
